NASA TECHNICAL NOTE

NASA TN D-3275

A STUDY OF SEVERAL OXIDATION-RESISTANT
COATINGS ON Cb-10Ti-5Zr ALLOY SHEET
AT 2000° F, 2400° F, AND 2700° F
(1365° K, 1590° K, AND 1755° K)

by W. Barry Lisagor and Bland A. Stein
Langley Research Center
Langley Station, Hampton, Va.

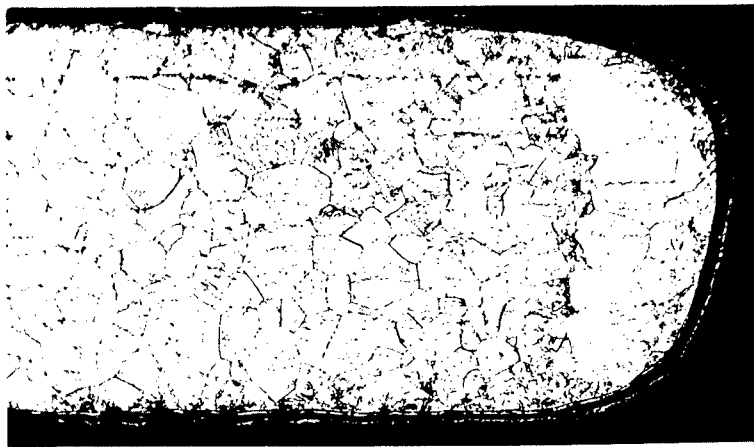
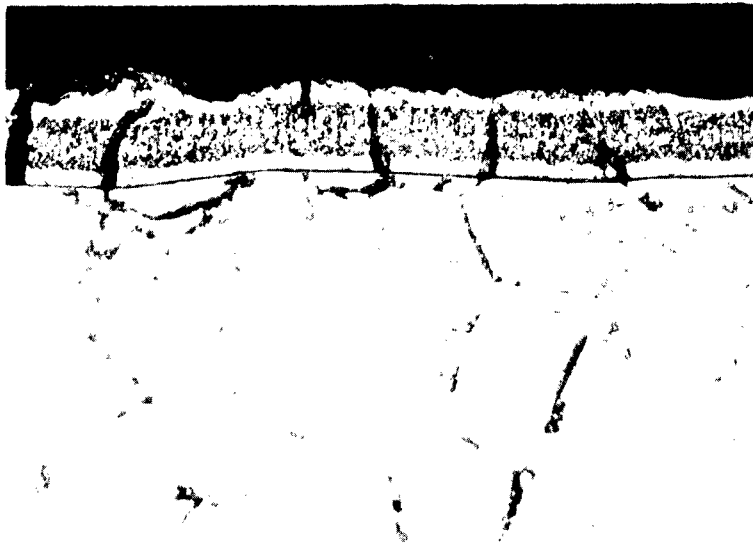
(a) As-coated appearance, X 2.

(b) Cross section, X 100.

(c) Cross section, X 500.

Figure 2.- Appearance of coating 1 on Cb-10Ti-5Zr alloy sheet in the as-coated condition.

Coating 1.- A relatively high columbium intensity was noted in the X-ray emission examination of the surface of coating 1. Also identified were Ti, Cr, Zr, Fe, and Si. The Fe intensity was high whereas the Si intensity was low. X-ray diffraction analysis indicated the primary compound to be CbB_2 . It should be noted here that boron is presently unidentifiable by X-ray emission techniques because the low-energy characteristic X-rays of boron cannot be detected. The as-received appearance of specimens of coating 1 is shown in figure 2. Substrate appearance may be compared with cross sections of the uncoated columbium alloy sheet in figure 3. The coated surface was dull black in color and relatively smooth in texture, some signs of nonuniformity being indicated by areas of different texture. Comparison of the uncoated grain size (fig. 3) and the substrate grain size in the coated specimen (fig. 2) indicates that some substrate grain growth resulted from the coating procedure. The metallographic studies showed some indications of substrate contamination due to the coating operation as evidenced by the appearance of precipitate particles. However, no indication of a continuous network of contaminants was observed in the substrate.

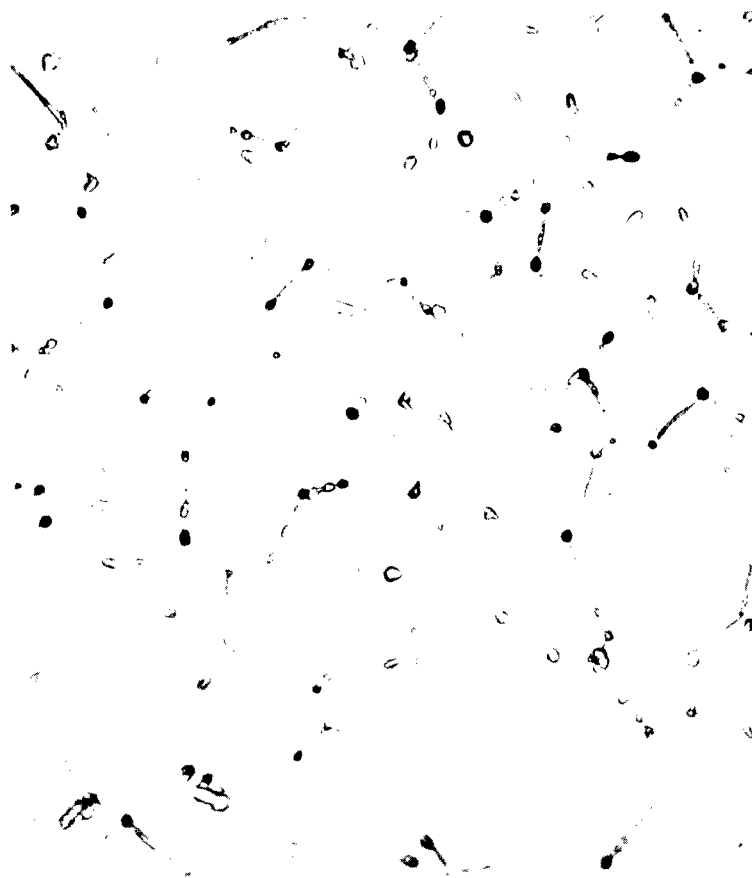
(a) Cross section, X 100.

(b) Cross section, X 500.

Figure 3.- Photomicrographs of Cb-10Ti-5Zr alloy sheet in the annealed condition.

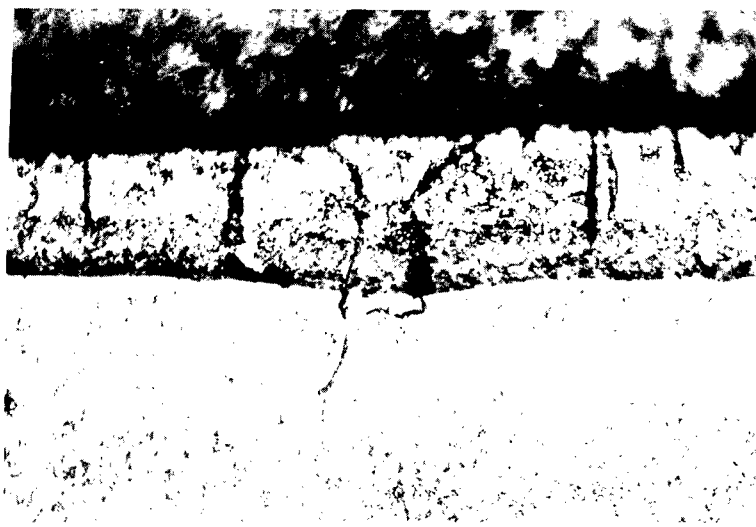
(b) Cross section, X 100.

(c) Cross section, X 500.

Figure 6.- Appearance of coating 2 on Cb-10Ti-5Zr alloy sheet in the as-coated condition.

Coating 2.- Results of the X-ray analysis (table II) showed the same elements present as for coating 1 and again the primary phase identification by X-ray diffraction was CbB₂. Coating appearance in the as-received condition is shown in figure 6. The surface appearance of the coating was similar to that of coating 1, but the coating thickness was approximately twice that of coating 1 (table I). Metallographic examination of coating 2 showed that the substrate itself was more severely affected by contaminants; as a result there was a continuous network of precipitates in the grain boundaries and subsequent severe embrittlement. The room-temperature tensile test results are shown in table III. The marked change in tensile properties indicate severe alteration of the base material by the coating process itself. The process lowered the tensile strength from 76 ksi to 49 ksi (525 to 338 MN/m²) increased the elastic modulus from 15×10^6 to 24×10^6 psi (103 to 166 GN/m²) and completely embrittled the substrate. Results of the elevated-temperature tensile tests (table IV) indicate the resultant specimen is actually stronger at 2400° F than the uncoated material, but tensile elongation was still negligible at 2000° F (1365° K) and only 4 percent at 2400° F (1590° K). Results of the bend tests also indicated complete embrittlement of substrate as found in the tensile tests (table I).

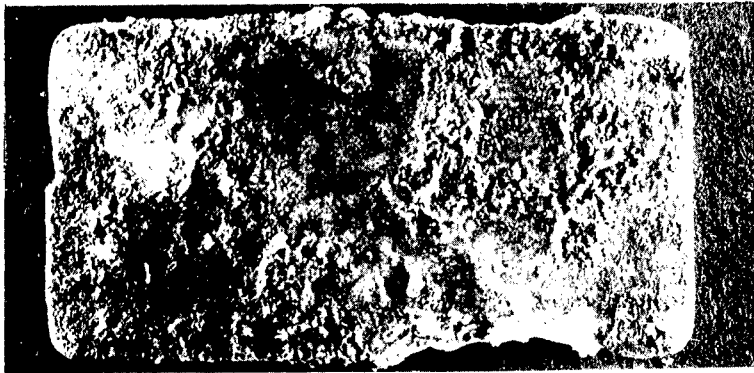
(a) 69-hour exposure at 2000° F (1365° K).

(b) 4-hour exposure at 2400° F (1590° K).

Figure 8.- Photographs of tested specimens of coating 2 on Cb-10Ti-5Zr alloy sheet exposed in air at atmospheric pressure, X 2.

Results of the cyclic and continuous oxidation tests are shown in figure 7, and the appearances of exposed specimens are shown in figure 8. Again, as was noted in coating 1, specimen appearance after exposure suggested different reaction products at all three test temperatures. Failure at 2700° F (1755° K) occurred immediately on insertion into the furnace and appeared to be caused by melting of the specimen rather than by oxidation of the substrate.

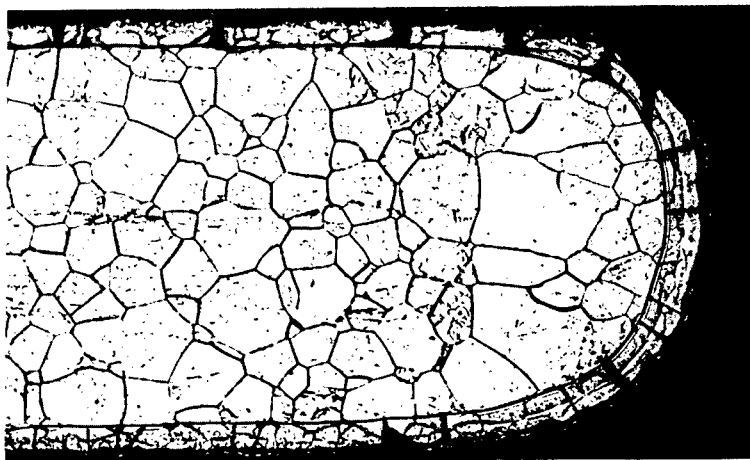
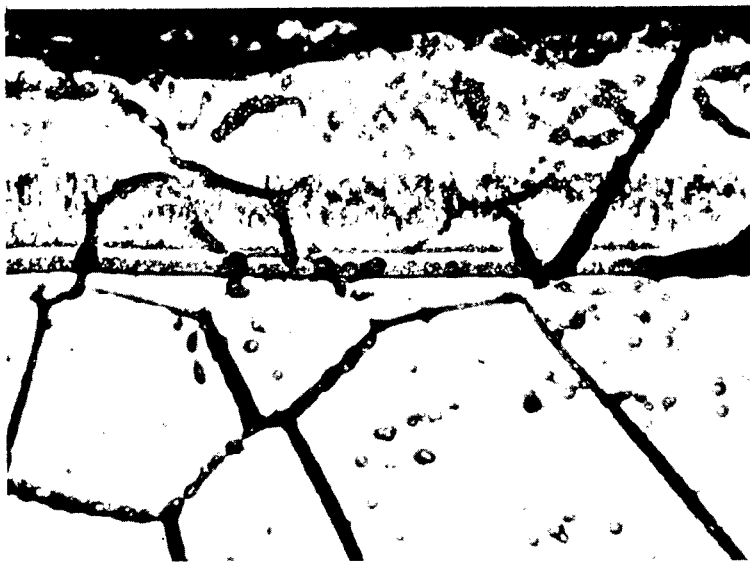
(a) As-coated appearance, X 2.

(b) Cross section, X 100.

(c) Cross section, X 500.

Figure 9.- Appearance of coating 3 on Cb-10Ti-5Zr alloy sheet in the as-coated condition.

Coating 3.- Although the coating procedure consisted of a first cycle of silicon and a second cycle of chromium and boron, the primary outer structure was found to be CbSi₂ and Cb₅Si₃ (table II). The appearance of this coating in the as-received condition is shown in figure 9. The coating appearance was dull gray, relatively smooth in texture, but had some darker spots dispersed over the entire coating. Once again, grain growth

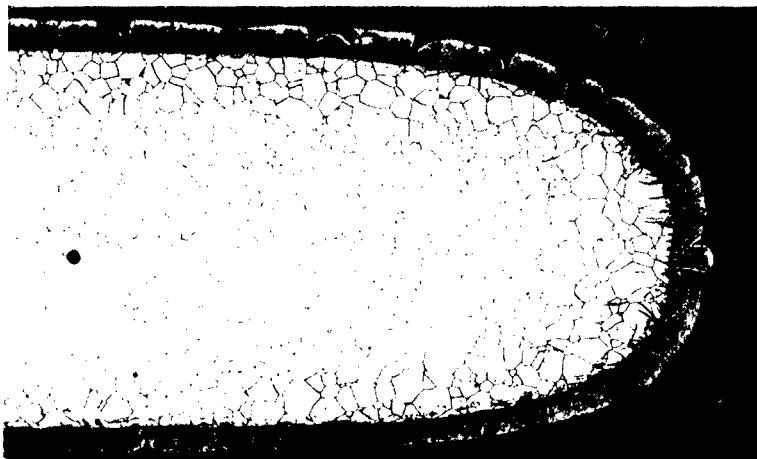
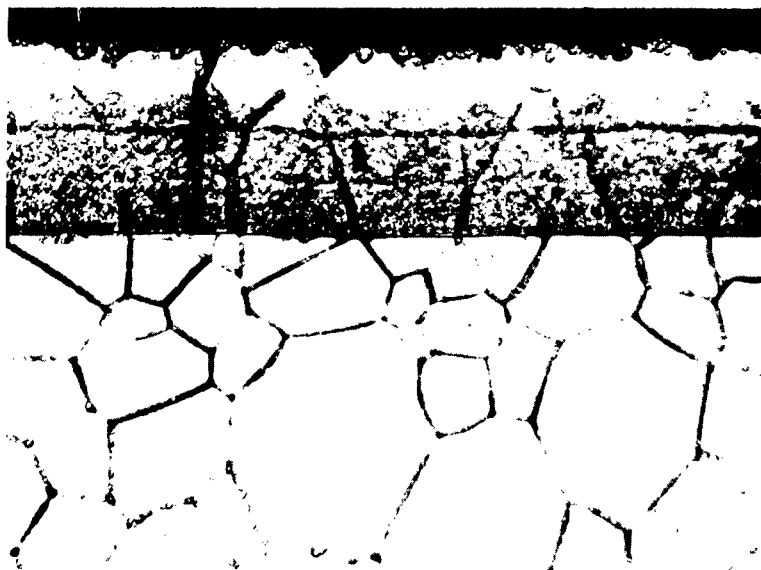
(a) As-coated appearance, X 2.

(b) Cross section, X 100.

—SiC overcoat

(c) Cross section, X 500.

Figure 16.- Appearance of coating 5 on Cb-10Ti-5Zr alloy sheet in the as-coated condition, showing SiC overcoat layer.

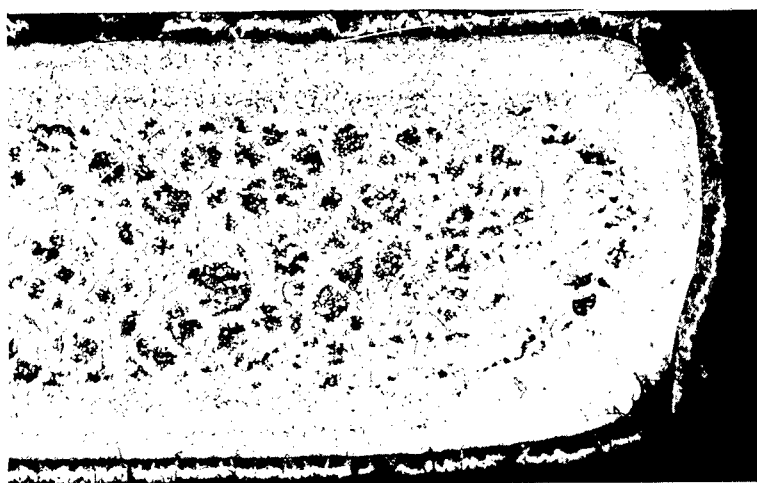
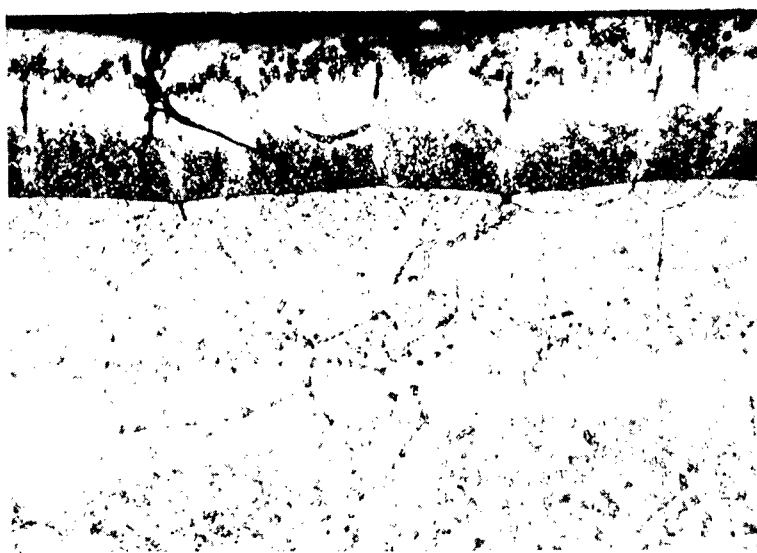
(b) Cross section, X 100.

(c) Cross section, X 500.

Figure 19.- Appearance of coating 6 on Cb-10Ti-5Zr alloy sheet in the as-coated condition.

Coating 6. - Results of the X-ray study on coating 6 (table II) indicate a relatively low silicon and columbium intensity, high chromium intensity, and appreciable intensity of titanium and chromium. X-ray diffraction and emission comparisons indicate the primary compound to be a solid solution of CbSi₂ and CrSi₂. The appearance of this coating in the as-received condition is shown in figure 19. The surface appearance was very uniform, light gray in color, and smooth in texture, but metallographic examination

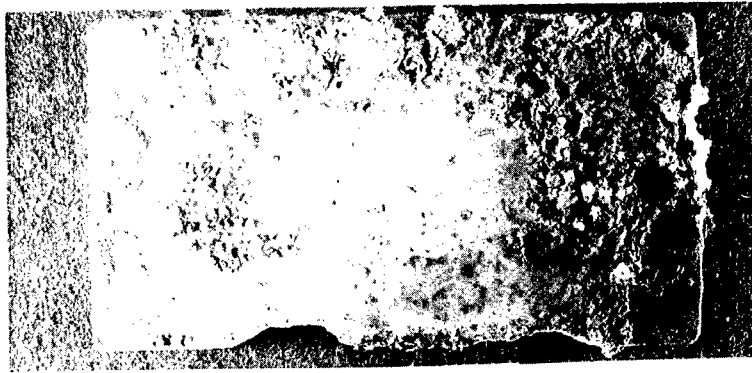
(a) 144-hour exposure at 2000° F (1365° K).

(b) 75-hour exposure at 2400° F (1590° K).

Figure 21.- Photographs of tested specimens of coating 6 on Cb-10Ti-5Zr alloy sheet exposed in dry air at atmospheric pressure under the conditions noted. X 2.

Results of the oxidation tests at atmospheric pressure (101 kN/m^2) are shown in figure 20 and the appearances of the exposed specimens are shown in figure 21. There was little damage at 2000° F (1365° K) before 140-hours exposure. At 2400° F (1590° K) severe damage began after approximately 30-hours exposure. At 2700° F (1755° K) tests were terminated from 1 to 24 hours.

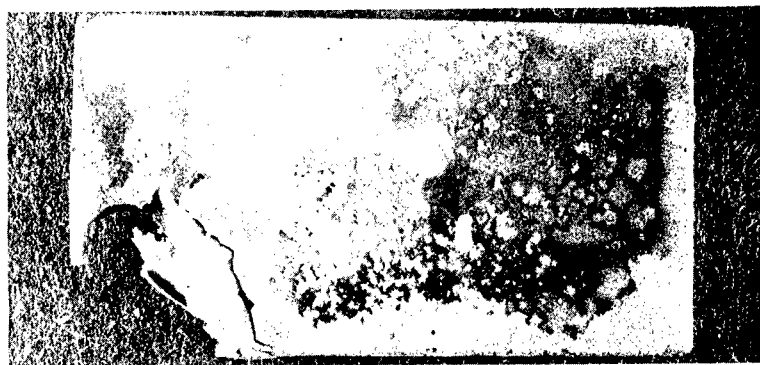
(a) 140-hour exposure at 2000° F (1365° K).

(b) 105-hour exposure at 2400° F (1590° K).

(c) 6-hour exposure at 2700° F (1755° K).

Figure 27.- Photographs of tested specimens of coating 8 on Cb-10Ti-5Zr alloy sheet exposed in dry air at atmospheric pressure. X 2.

Results of the oxidation study at atmospheric pressure (101 kN/m^2) and also at reduced pressures are shown in figure 26 and macro-photographs of exposed specimens are shown in figure 27 for atmospheric pressure and in figure 28 for the reduced pressure tests. At 2000°F (1366°K) oxidation protection was good for a minimum of 140 hours. At 2400°F (1590°K) cyclic oxidation life was reduced to approximately 100 hours. Further reductions in lifetime were noted at 2700°F . The low-pressure test results indicate a very small mass change as shown in figure 26 with no visual evidence of failure.

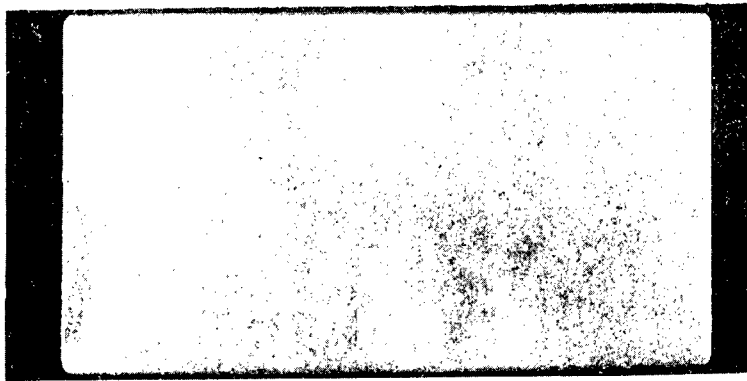
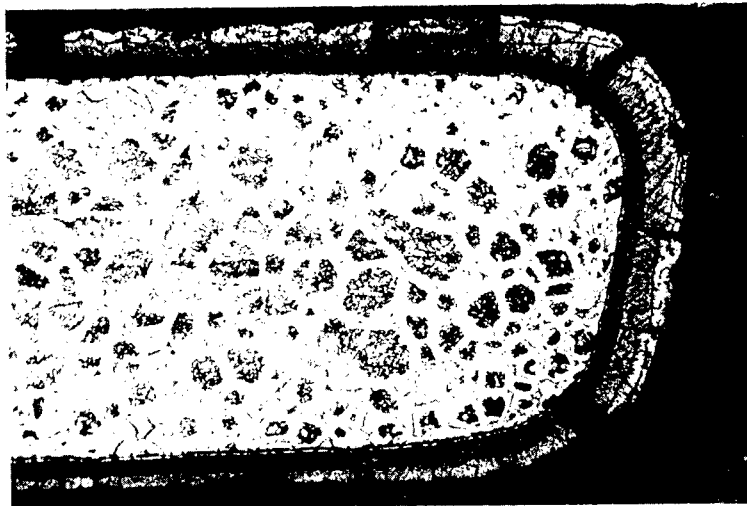
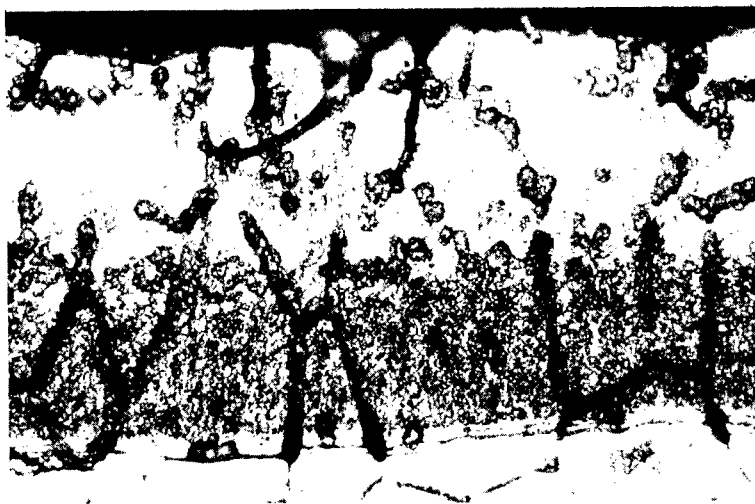
(a) As-coated appearance, X 2.

(b) Cross section, X 100.

(c) Cross section, X 500.

Figure 29.- Appearance of coating 9 on Cb-10Ti-5Zr alloy sheet in the as-coated condition.

Coating 9.- The X-ray study on coating 9 resulted in identification of chromium, titanium, and silicon from the coating process with intensities as reported in table II; columbium and zirconium from the substrate were also identified. The primary compound was identified as a solid solution of CrSi_2 and CbSi_2 . The appearance of coating 9 is shown in figure 29 in the as-received condition. The metallographic examinations revealed severe alteration of the base material by the coating process, with general precipitation of particles. The coating process did not cause appreciable grain growth.

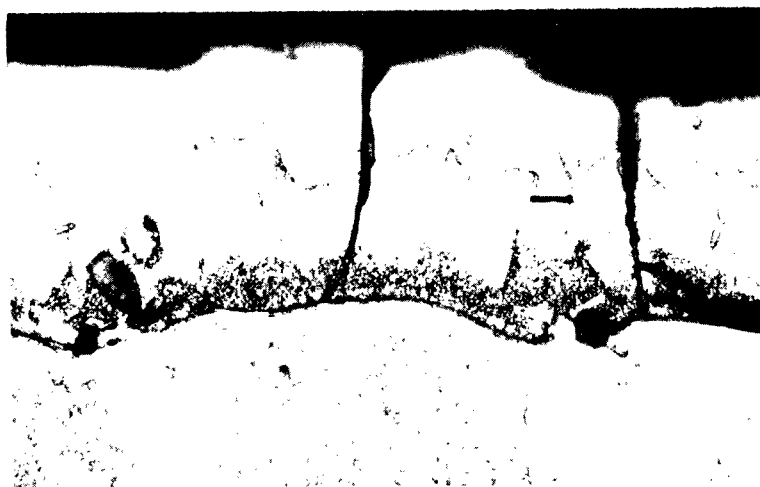
(b) Cross section, X 100.

(c) Cross section, X 500.

Figure 39.- Appearance of coating 12 on Cb-10Ti-5Zr alloy sheet in the as-coated condition.

Coating 12.- Results of the X-ray study on coating 12 indicate that this coating had the highest intensities of chromium and silicon relative to the other coatings and a high intensity of titanium (table II). Lower intensities of columbium and zirconium were also observed. The primary crystal structure was that of $\text{CrSi}_2\text{-CbSi}_2$ solid solution. Views of this coating in the as-received condition are shown in figure 39. This coating was also speckled gray in appearance and had a medium smooth texture. Metallographic examinations indicate no precipitates in the substrate. A well-defined diffused layer and considerable grain growth were evident after the coating process. Room-temperature tensile data indicate no change in tensile strength due to the coating application, but a decrease in elongation from 30 to 14 percent was observed (table III). Specimens exposed at 2400° F for 8 hours exhibited a further reduction in elongation to 4 percent. Elevated-temperature tensile tests (table IV) indicated that the ultimate strength was similar to that of the uncoated material and specimens of other coatings.

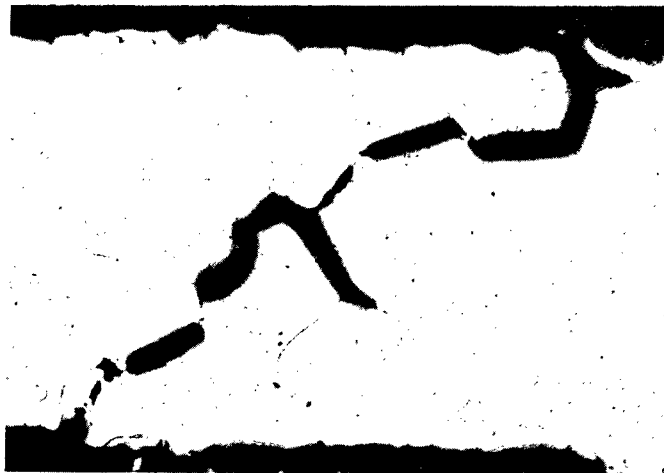
(a) Bright-field illumination, metallograph, X 100.

Figure 46.- Cross sections of a specimen of coating 12, after 240 one-hour cycles at 2000° F (1365° K) in air at 760 mm Hg (101 kN/m²) and a room-temperature bend test.

The oxidation and bend-test results indicate that specimens of this coating exhibited embrittlement of the substrate when cyclically exposed, and showed no evidence of oxidation damage. After 240 one-hour cycles at 2000° F there was no visual evidence of failure and no mass changes of large magnitude; however, bend tests resulted in brittle fracture (table V). The specimen tested continuously for 240 hours at 2000° F was not embrittled. Reduced pressure tests at 0.05 torr resulted in severe embrittlement after 20 one-hour cycles at 2400° F with no obvious oxidation damage.
